# ANNUAL INSPECTION REPORT NEARMAN CREEK BOTTOM ASH IMPOUNDMENT

Kansas City, Kansas

**B&V PROJECT NO. 190719**

13 JANUARY 2016

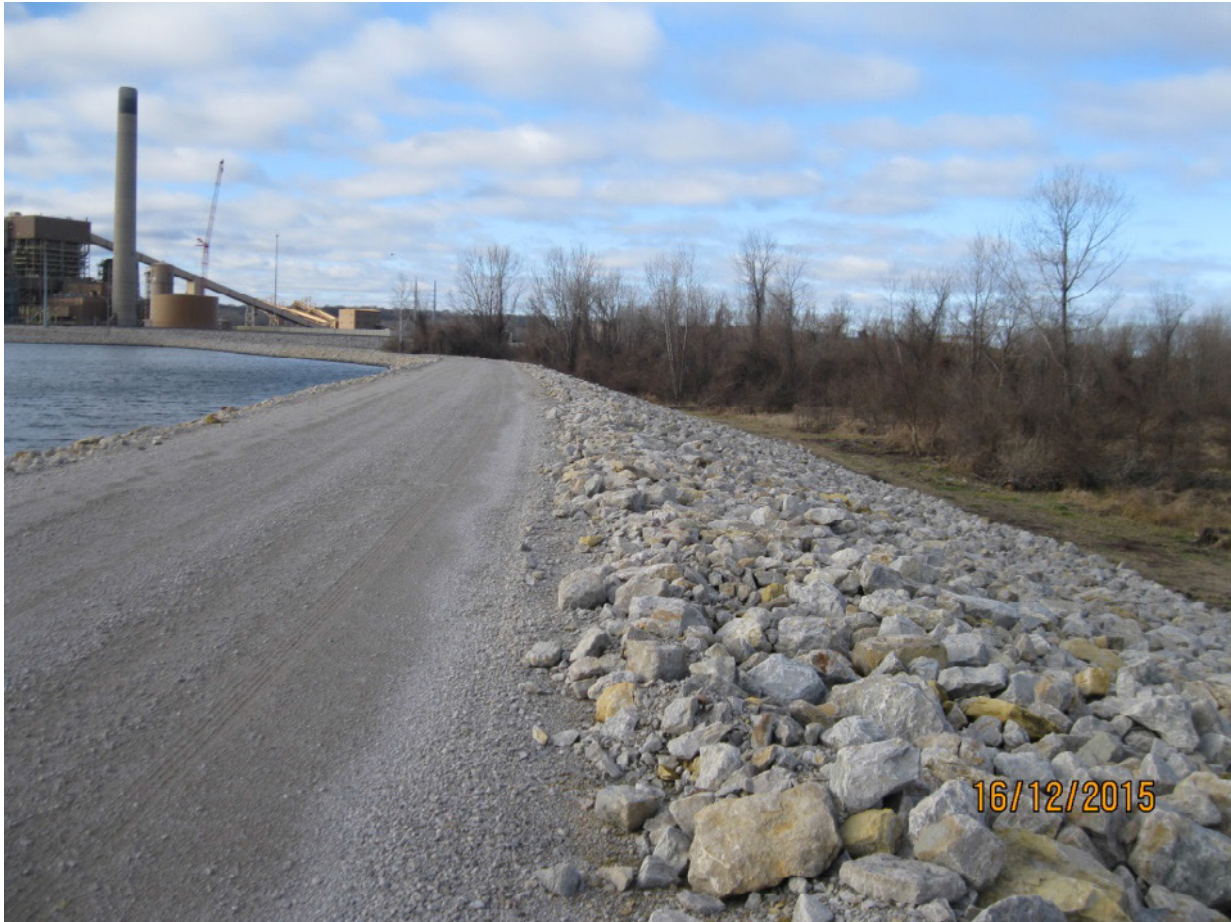
The interior and exterior dike crest surfaces are covered with gravel road base material. The crest of the dikes appeared to be in good condition (Figure 4-1). No signs of cracking, settlement, movement, erosion or deterioration were observed during the assessment.

Figure 4-1 Exterior Dike Crest Condition

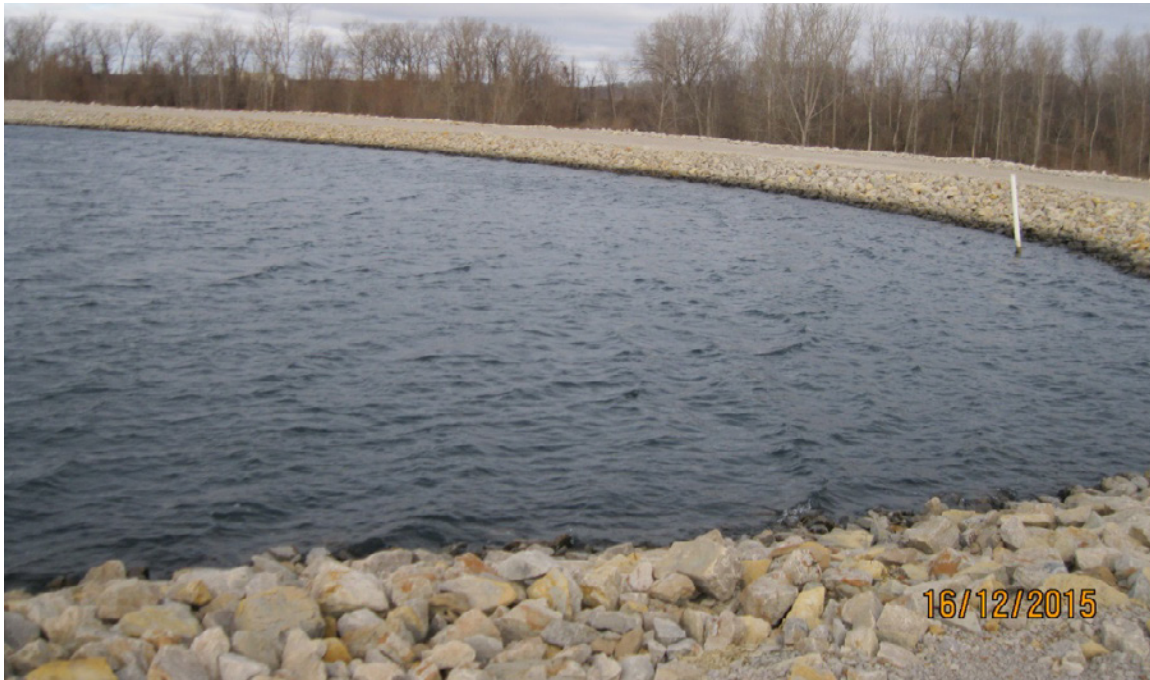
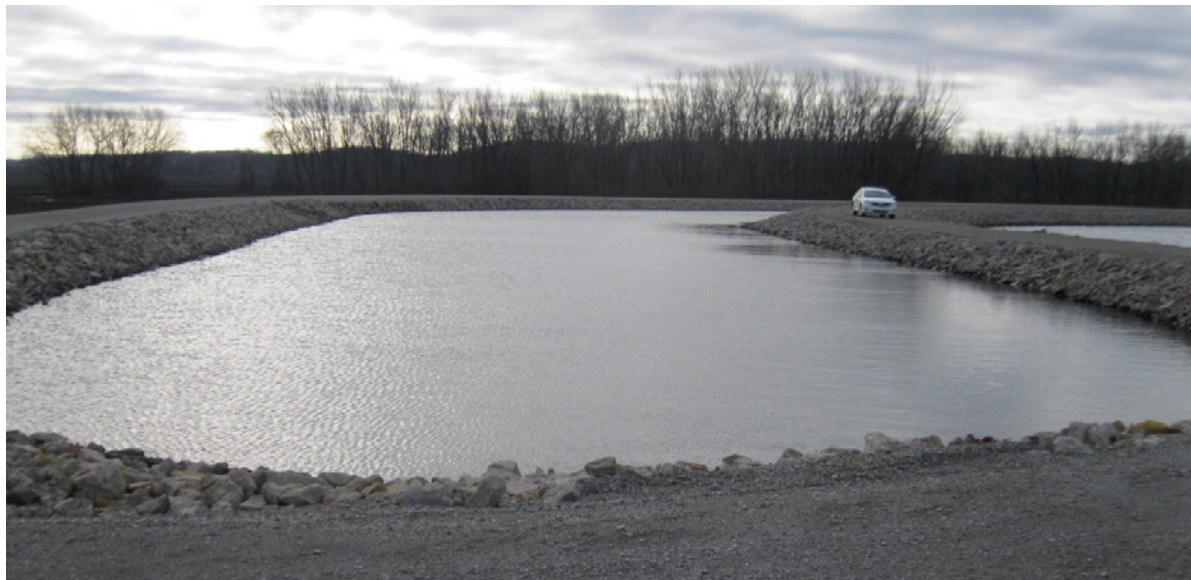
The interior slopes of the bottom ash and clear water pond dikes are protected by riprap and appeared to be in excellent condition (Figure 4-2a and b). There were no signs of erosion or surface instability. Minimal vegetation was observed within the slopes.

**Figure 4-2 Bottom Ash (a) and Clear Water (b) Pond Interior Slope Conditions**

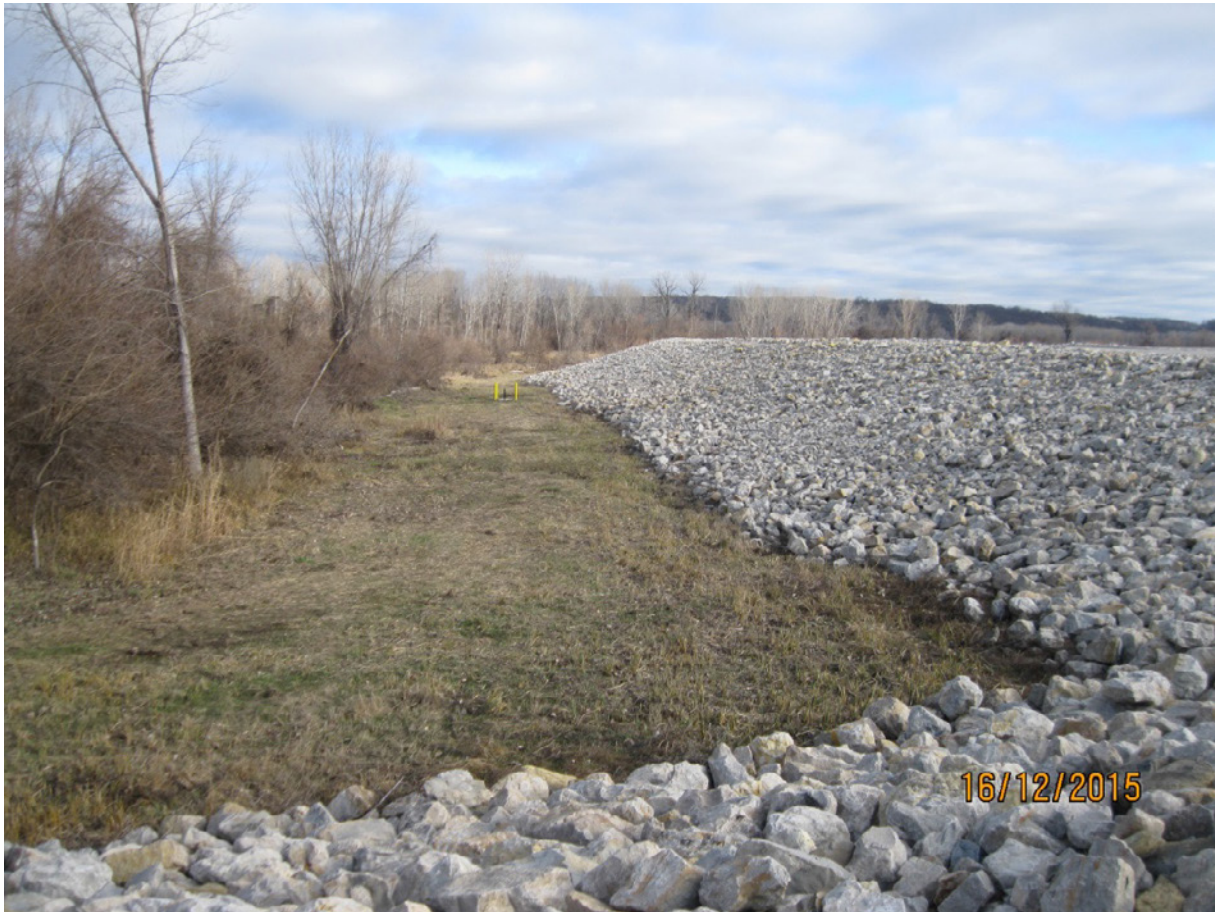
In the northern portion of the impoundment, the exterior dike slope surface is covered with large riprap and appears to be in excellent condition (Figure 4-3). There were no indications of slumping or instability observed on this portion of the impoundment. Little to no vegetation was noted within the riprap.

Figure 4-3 Exterior Dike Slope in North Facing Slope of Impoundment

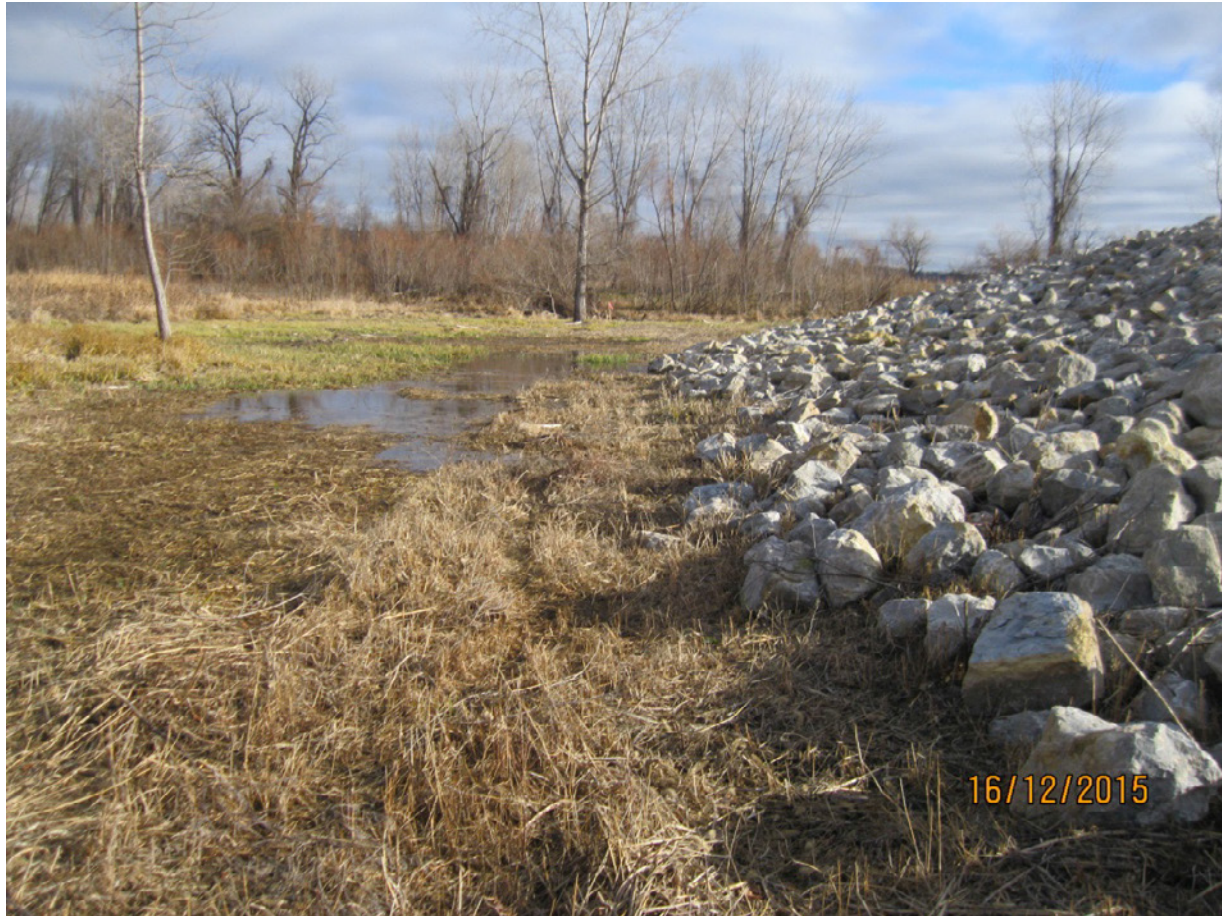
At the time of the inspection, standing water was noted at the toe of portions of the north facing slope (Figure 4-4). The standing water was clear with no indications of sediment or seepage issues at this location.

**Figure 4-4 Standing Water along Toe of North Facing Slope**

The toe area on the north facing exterior slope should be regraded to prevent standing water from accumulating at the toe of the slope.

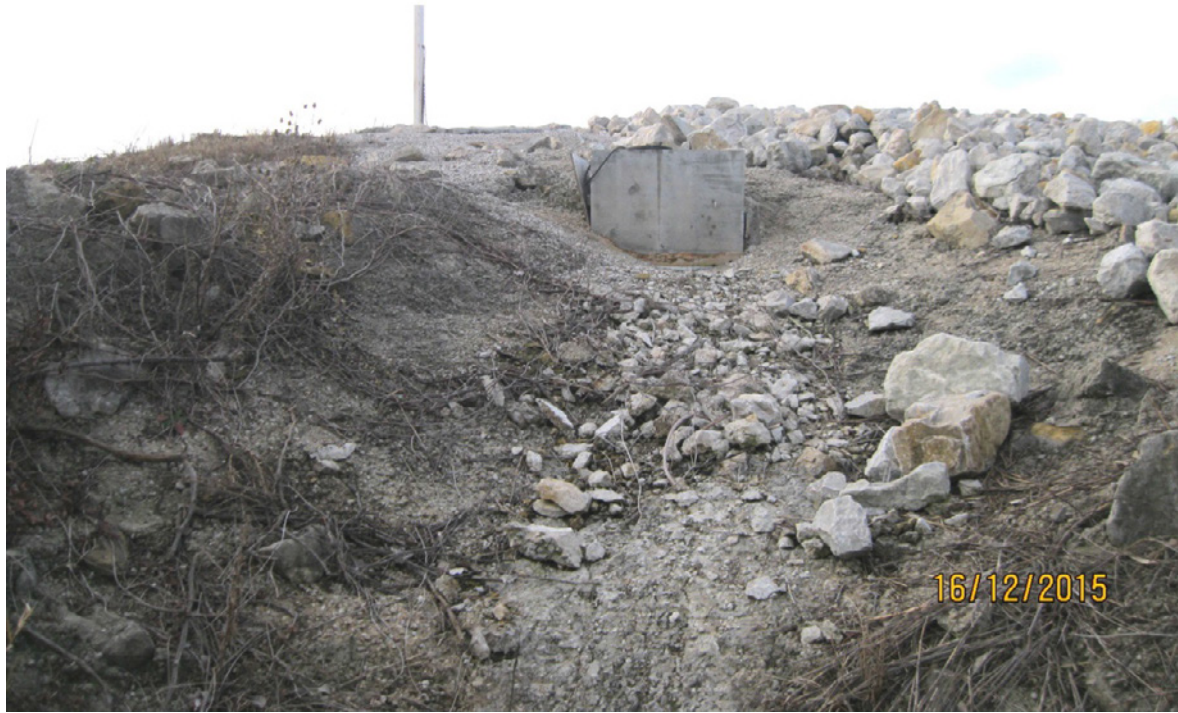
The riprap covering on the northern portion of the exterior dike surface stops at approximately the location of the bottom ash pond discharge pipe (Figure 4-5). There appeared to be some concrete surfacing extending below the sealed discharge pipe. Some large riprap was also noted further east of the discharge pipe (Figure 4-6); however, the riprap was partially covered with vegetation and was not continuous with the riprap on the north facing exterior slope. While there did not appear to be any significant erosion issues at this location, there did appear to be exposed bare soil and minor unravelling of the riprap edges.

Figure 4-5 Exterior Dike Slope Surface at Discharge Pipe.

In the area of the previously sealed bottom ash pond discharge pipe, the original design drawings indicate that riprap should extend along the exterior slope past the discharge pipe. The inspection indicated that the riprap was not continuous past the discharge pipe. While no significant erosion was observed at this location, bare soil was exposed and unravelling of existing riprap was observed; therefore the area should be repaired.

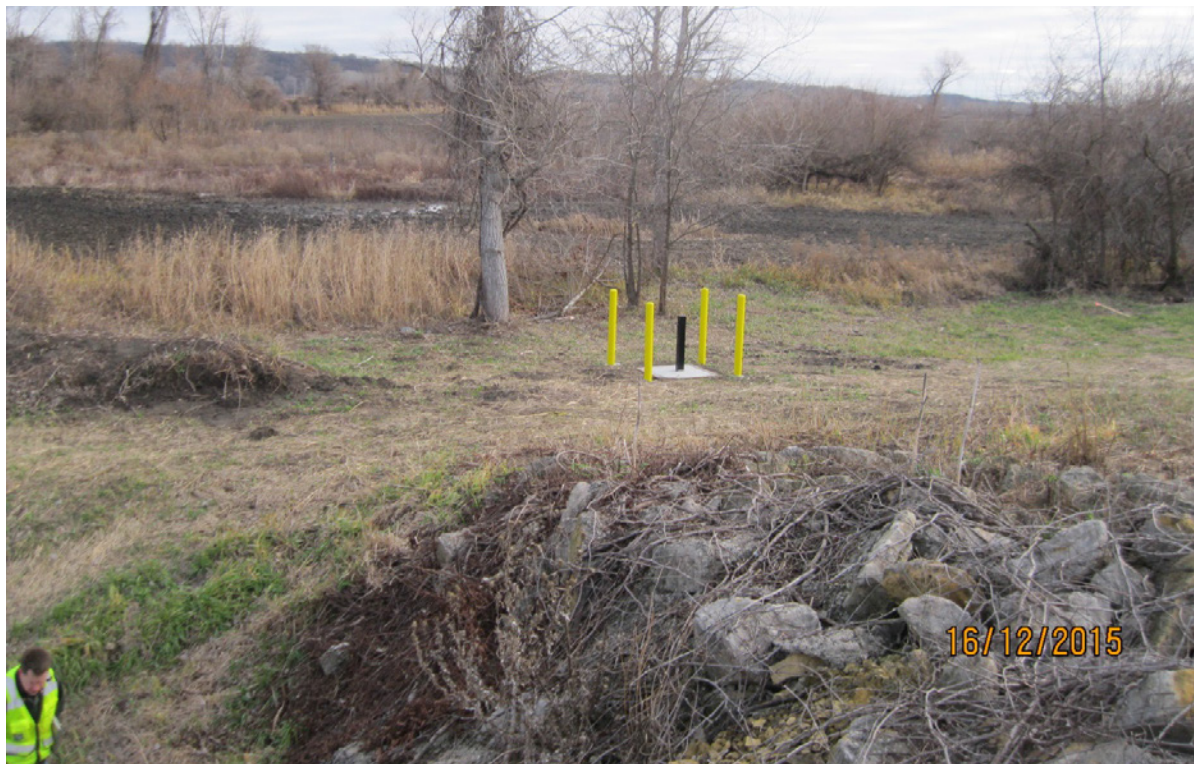
Figure 4-6 Exterior Dike Slope Surface East of the Discharge Pipe.

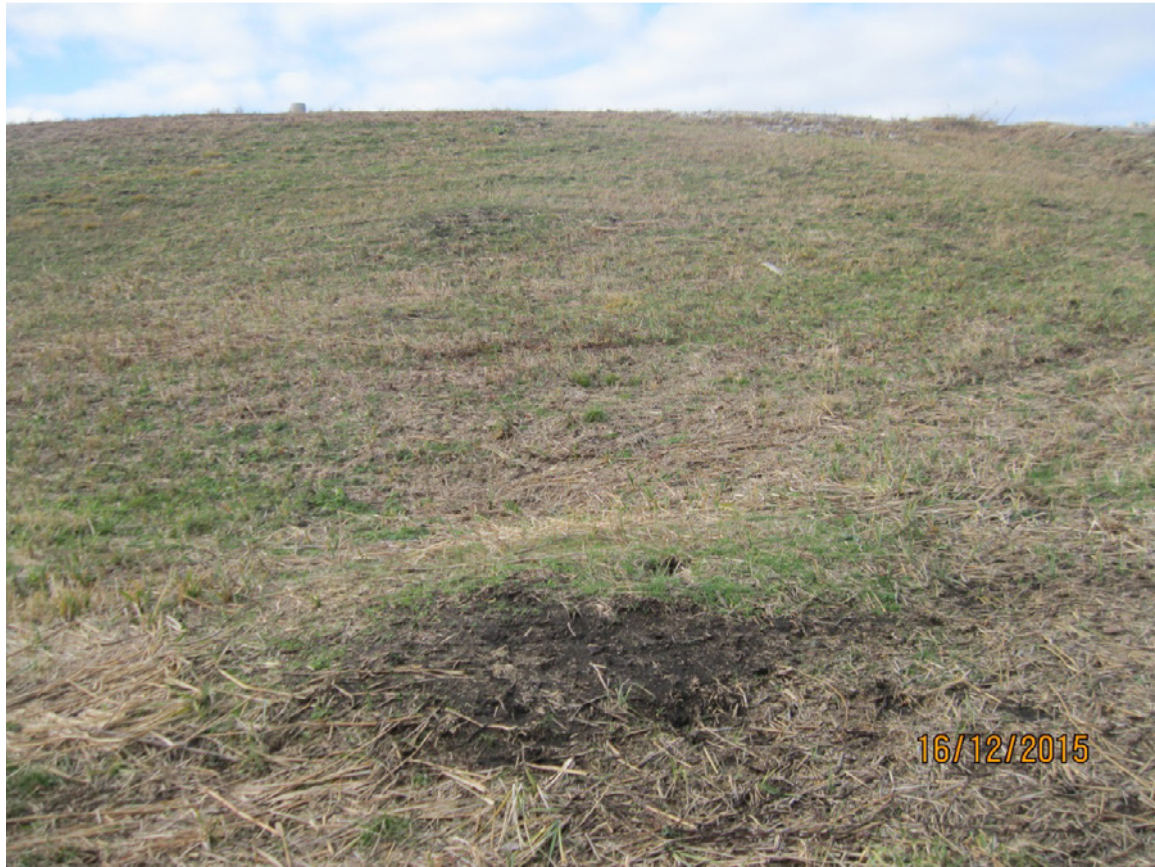
Along the east facing slope, there did appear to be some minor surface irregularities (Figures 4-7)

**Figure 4-7 Minor Surface Irregularity Along East Facing Exterior Slope.**

As shown in Figure 4-7, these surface irregularities appears as very low profile bulges on the slope with a height of generally less than 6 inches. The very small size suggests these may have been ruts that occurred during grading or maintenance operations. There were no signs of slope instability.

Along the east facing exterior slope, the minor surface irregularities and depressions should be regraded and seeded.

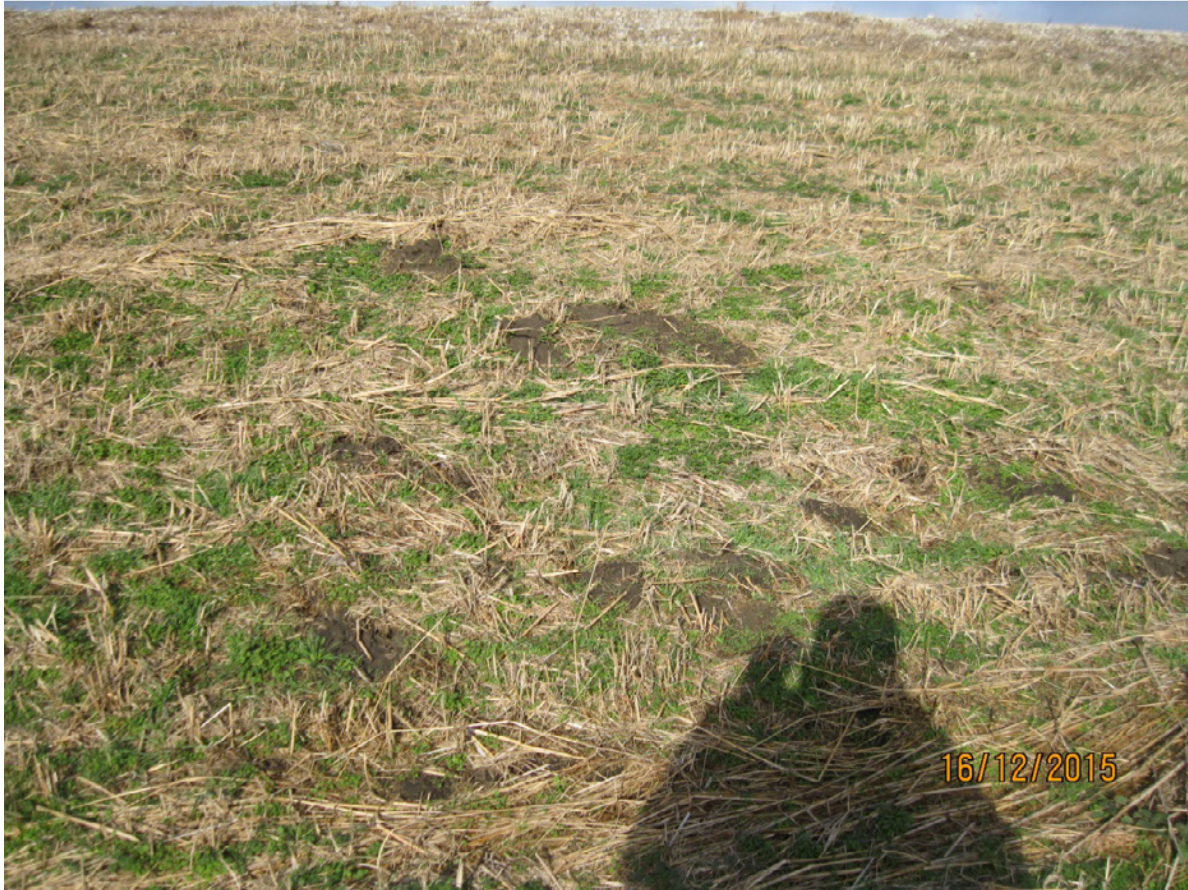
Along the southeast facing exterior slopes, some minor surface disturbances likely caused by animals were noted (Figure 4-8). None of the disturbances were deep enough to indicate issues with animal burrowing activity.

**Figure 4-8 Minor Surface Disturbances Along the Southeast Facing Exterior Slope.**

The minor surface disturbances along south facing exterior slopes should be monitored to ensure that additional disturbance or borrowing activity does not cause further disturbance to the slope.

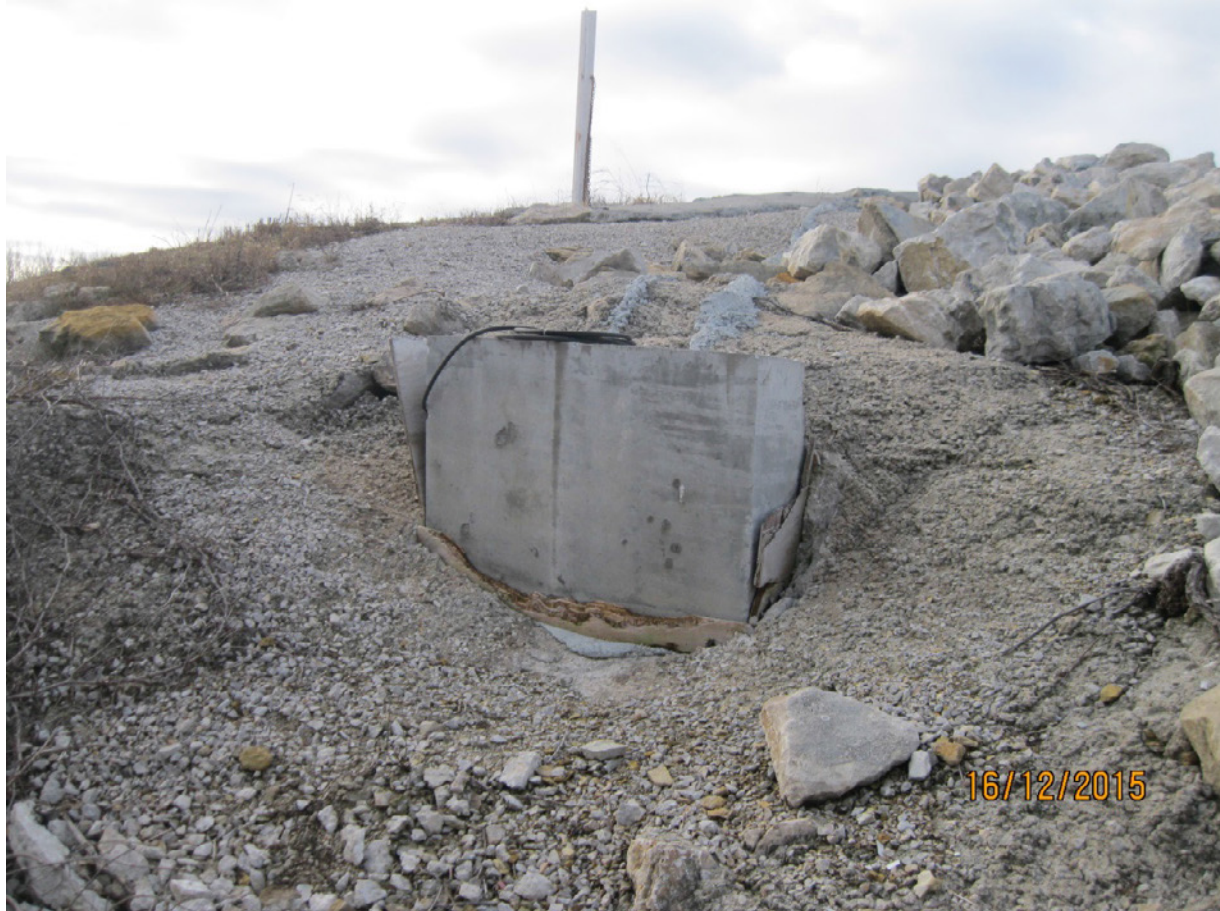
Only the 30 inch diameter discharge pipe for the bottom ash pond was visible for inspection. This discharge pipe has been permanently sealed with concrete as shown in Figure 4-9. There were no signs of seepage or structural instability.

**Figure 4-9 Bottom Ash Pond 30 Inch Diameter Discharge Pipe.**

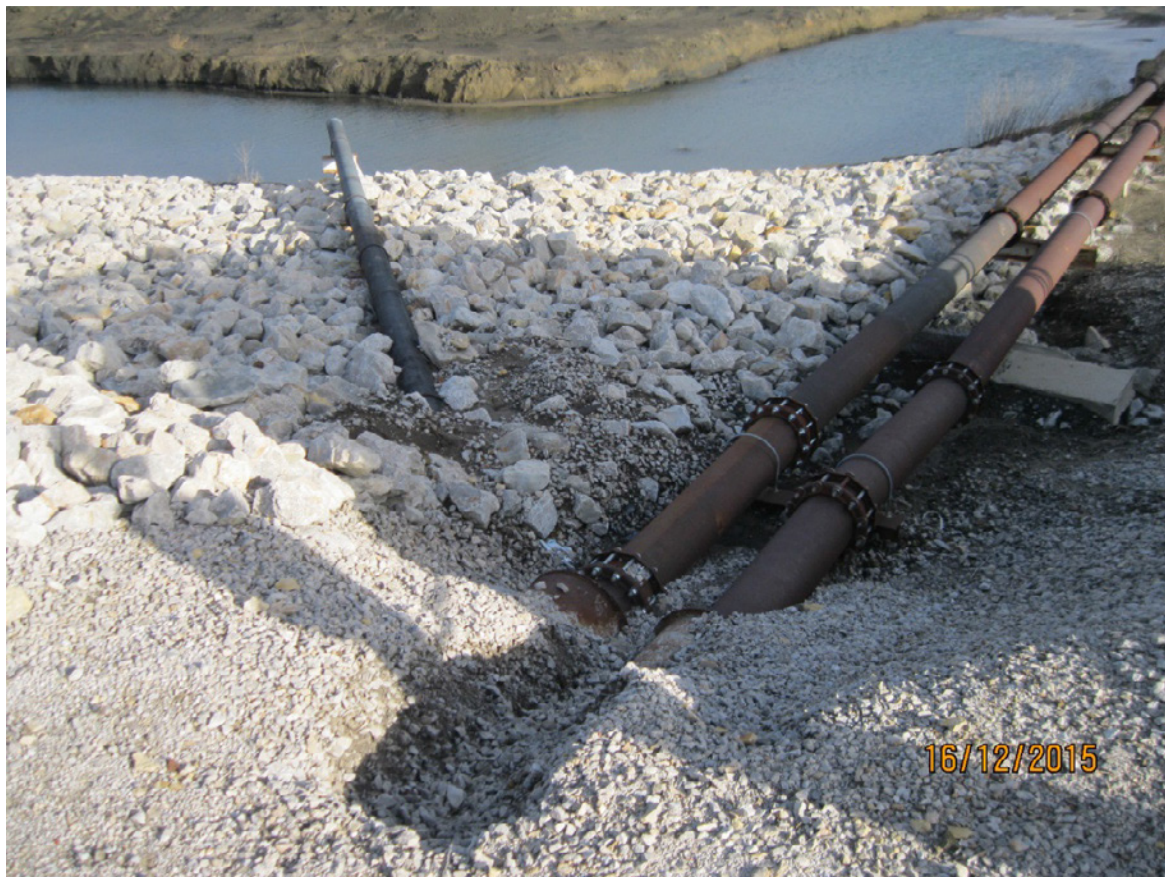
Additional structures observed during the inspection included the clear water pump house and bottom ash sluice pipes. A visual inspection of the exterior of the pump house indicated that the pump house was in good condition. The KCBPU staff indicated that the monthly equipment inspection of the sluicing system includes confirming the operation of the pump and gauges. The three bottom ash sluice pipe were also visually inspected and found to be in good working order. Minor erosion was noted where the sluice pipes pass beneath the plant access roads to the south of the impoundment (Figure 4-10).

Figure 4-10 Minor Erosion Along Bottom Ash Sluice Pipes

The erosion along the bottom ash discharge lines should be repaired to prevent further erosion of the plant access road.
