ANNUAL INSPECTION REPORT NEARMAN CREEK BOTTOM ASH IMPOUNDMENT

Kansas City, Kansas

B&V PROJECT NO. 190719
B&V FILE NO. 41.0403

28 DECEMBER 2017

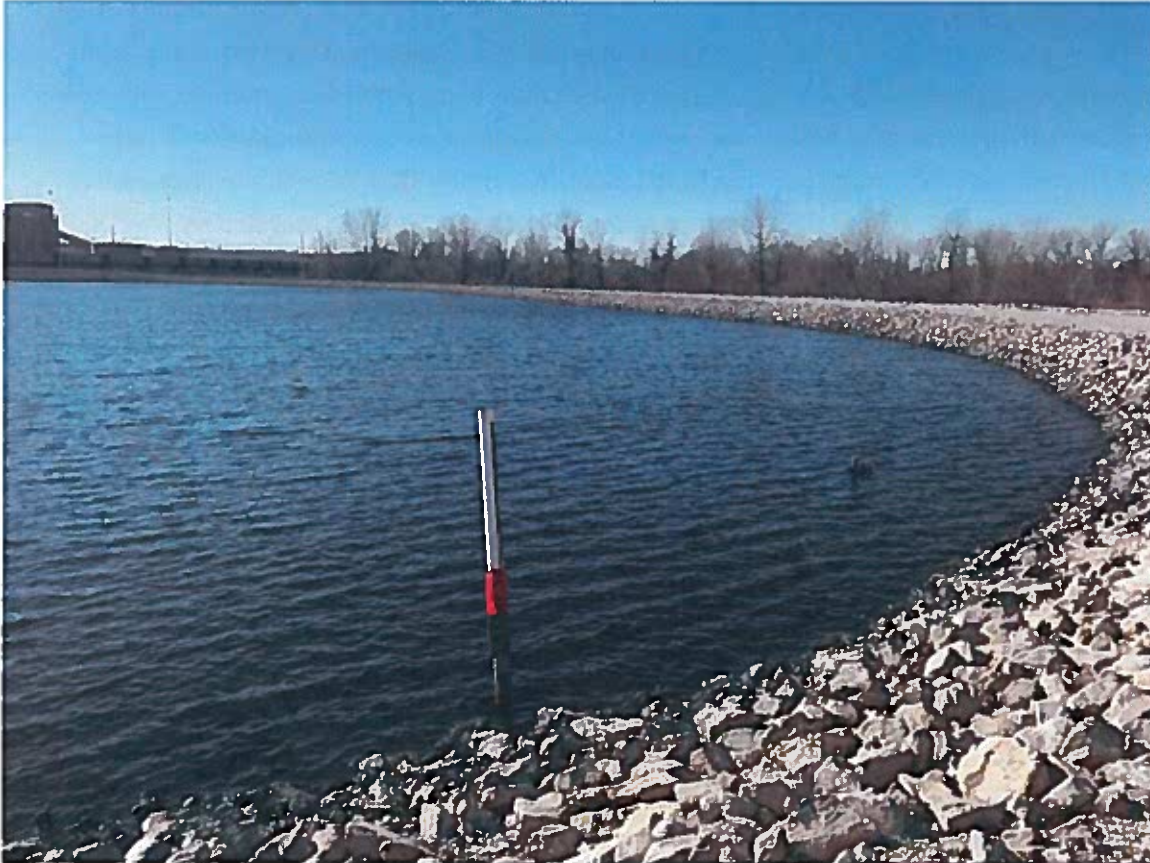
Figure 3-1 Water Level Indicator

There is a level indicator on the interior slope near the conduit between the ponds. The water level indicators are set to Elevation 760.59 at the top of the red marker, 759.55 at the top of the green marker and 758.49 at the bottom of the green marker. The approximate water elevation in the pond at the time of the inspection was Elevation 756.3 feet.

The interior slopes of the bottom ash and clear water pond dikes are protected by riprap and were in excellent condition (See Figure 3-1). There were no signs of erosion or surface instability. No vegetation was observed within the slopes. The previous water levels could be observed as the darker riprap materials. As shown in Figure 3-1, the top of a vertical pipe can be observed above the water. The vertical pipe is an indicator of the water elevations between the two ponds.

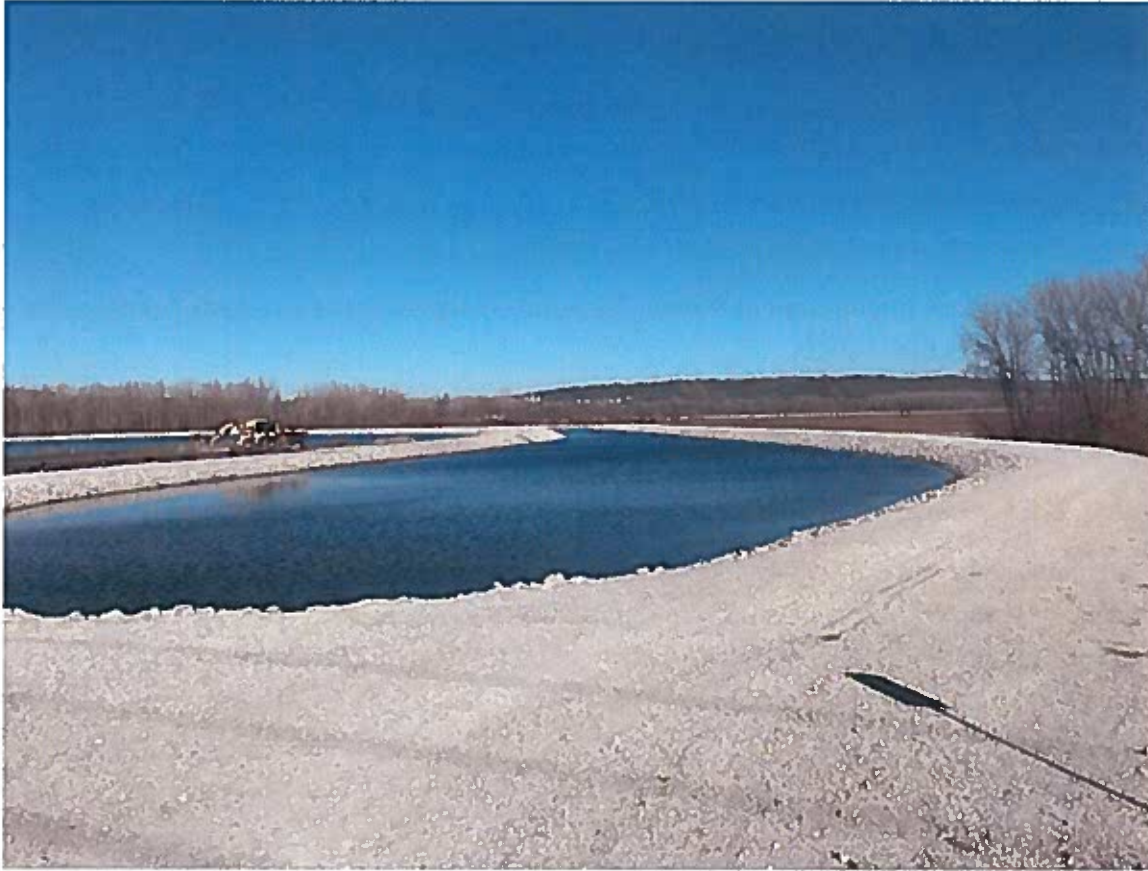
Figure 4-1 Interior Dike Crest Condition

The interior and exterior dike crest surfaces are covered with gravel road base material. The crest of the dikes were in good condition (Figure 4-1). No signs of cracking, settlement, movement, erosion or deterioration were observed during the assessment.

No vegetation was observed along the crest. The KCBPU staff indicated that vegetation has been periodically sprayed as part of the landscape maintenance and dead vegetation was observed.

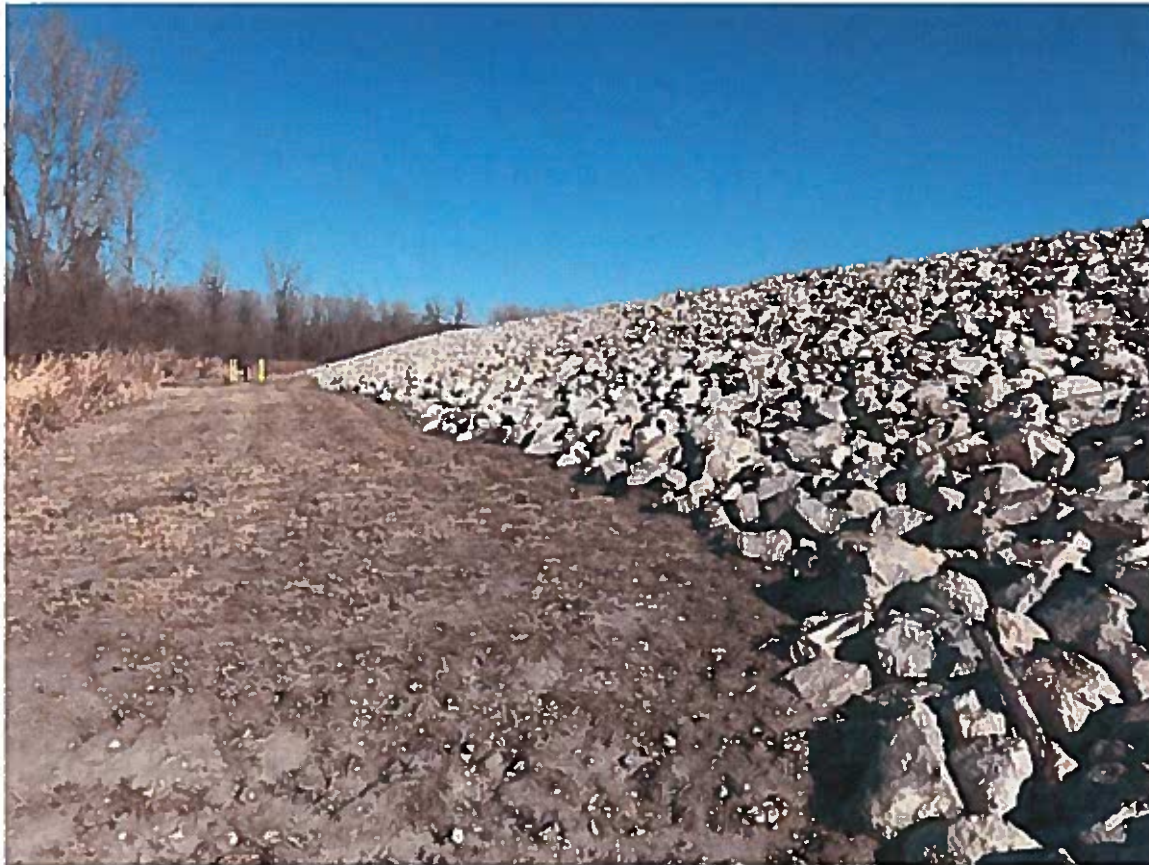
Figure 4-2 Exterior Dike Slope in North Facing Slope of Impoundment

In the northern portion of the impoundment, the exterior dike slope surface is covered with large riprap and appears to be in excellent condition (Figure 4-2). There were no indications of slumping or instability observed on this portion of the impoundment. No vegetation was noted within the riprap. The maintenance program includes periodic spraying of vegetation. The base of the slope is dry.

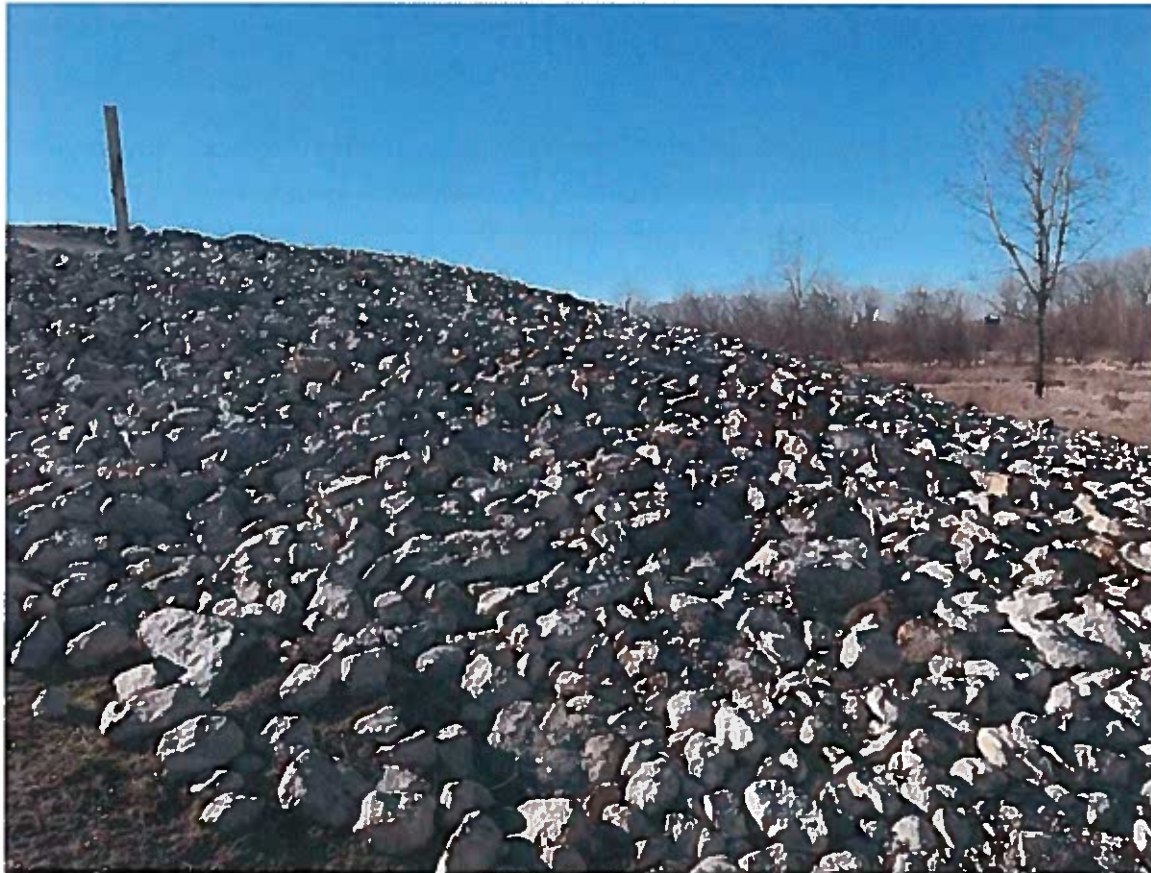
Figure 4-3 Exterior Dike Riprap Placement.

During the previous annual inspection, additional riprap had been placed near the outlet structure. The outlet structure is plugged, but the riprap had been placed to protect the grade below the outlet. Prior to this year's inspection, more riprap had been placed around the plugged outlet and extended to meet the east embankment (Figure 4-3). The riprap placement had been spread evenly along the face of the slope and was composed of intact limestone cobbles and boulders with little to no shale seams.

The former discharge structure was not visible due to the additional rip rap that had been placed during the past year (see Figure 4-3). There were no signs of seepage or structural instability. The new riprap has been placed over the structure and extended the rip rap to the south and east along the slope.

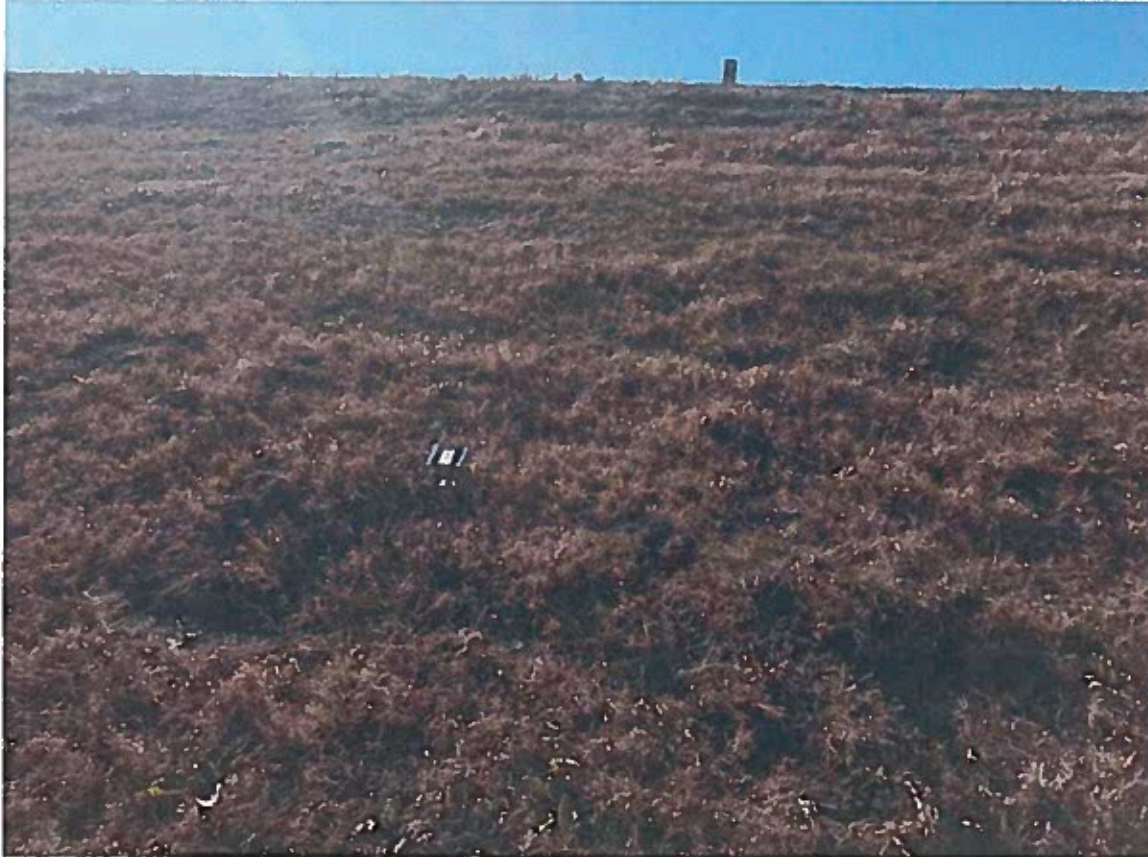
Figure 4-4 Animal trap placed due to weekly observation.

There were fewer observed animal burrows than the previous annual inspection. Animal tracks observed on recent weekly observations have been controlled with the use of traps (Figure 4-4). Trapping animals is part of the maintenance plan.
