ANNUAL INSPECTION REPORT

NEARMAN CREEK BOTTOM ASH IMPOUNDMENT

Kansas City, Kansas

31 DECEMBER 2018

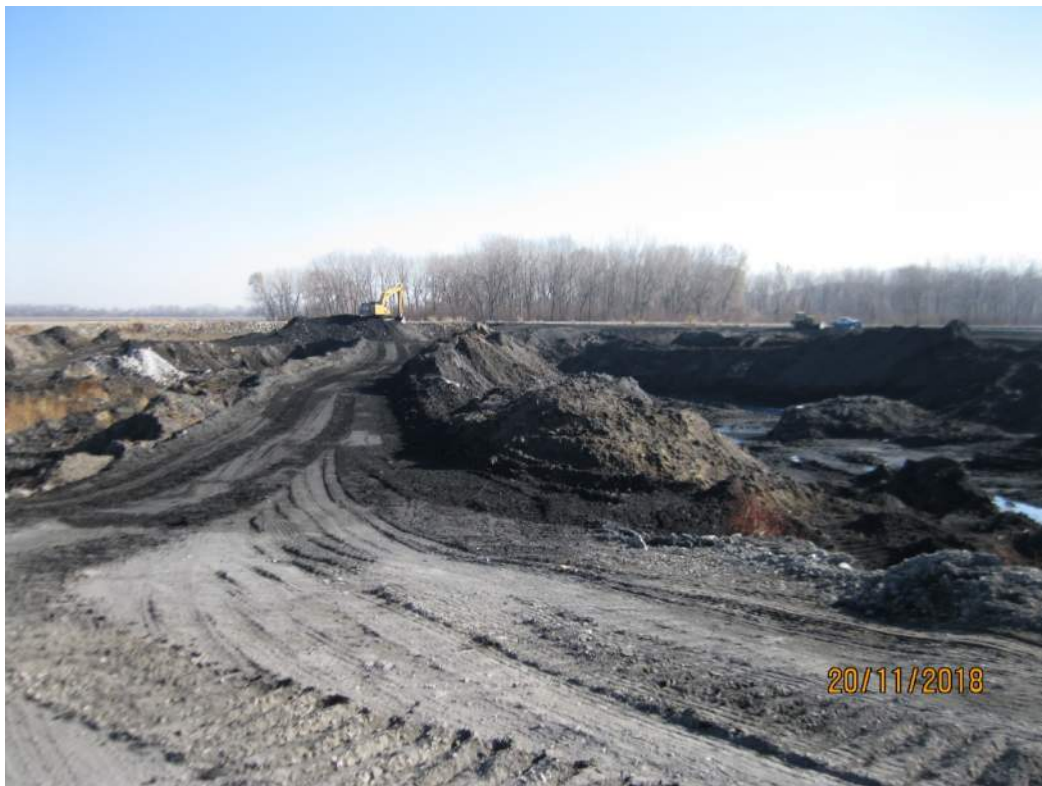
At the time of this inspection, bottom ash was being excavated from the impoundment and being hauled offsite for beneficial use. The KCBPU received approval from KDHE on March 16, 2018 for a low-volume wastewater discharge of the surface impoundment via KDHE permit No. I-MO25-B001. The two ponds are normally hydraulically connected by a 24-inch diameter reinforced concrete pipe (RCP). The pipe has been abandoned in place and the water is intermittently pumped from the bottom ash pond to the clear water pond. The dry condition of the impoundment allowed a single backhoe and multiple dump trucks to excavate and remove the bottom ash. (See Figure 1).

Figure 1 – Dry Bottom Ash Impoundment – Removal by Backhoe and Dump Trucks

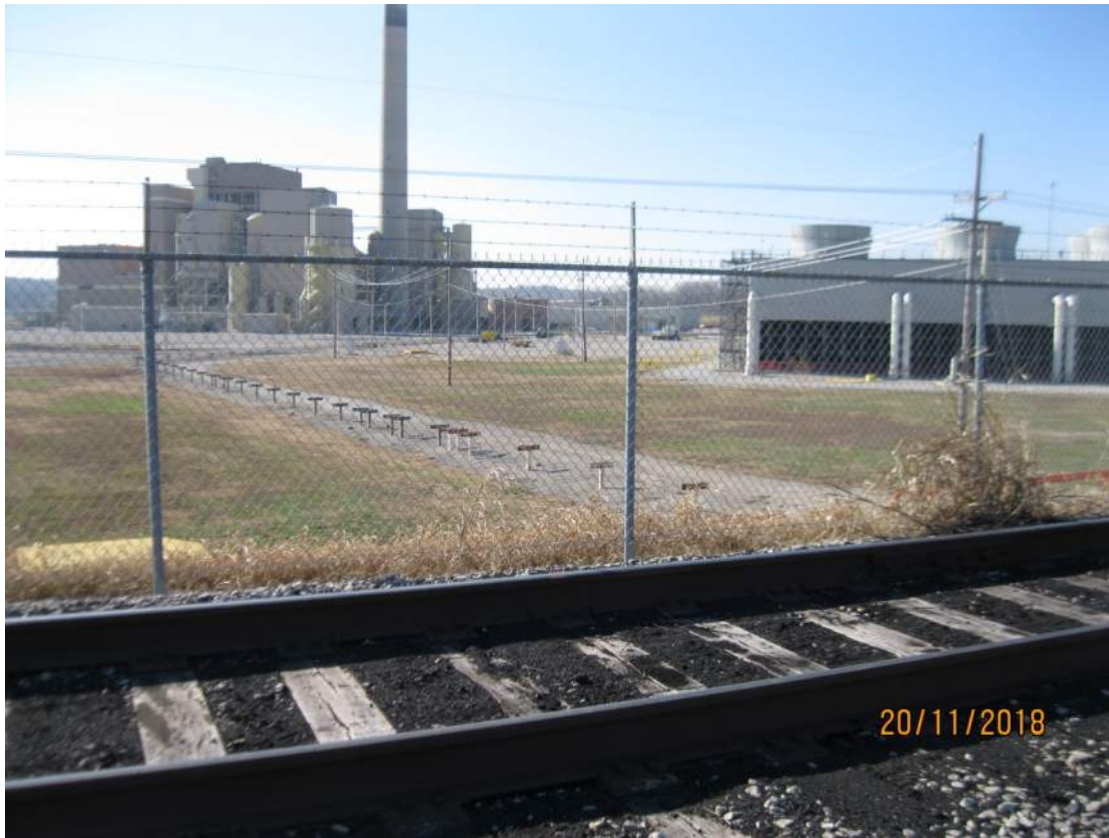
The pipes used to sluice the bottom ash to the pond had been removed as part of the plant conversion from a wet bottom ash system to a dry system. No additional bottom ash is being pumped into the impoundment. (See Figure 2).

Figure 2 – Remaining Pipe Supports along Sluce Pipe Alignment.

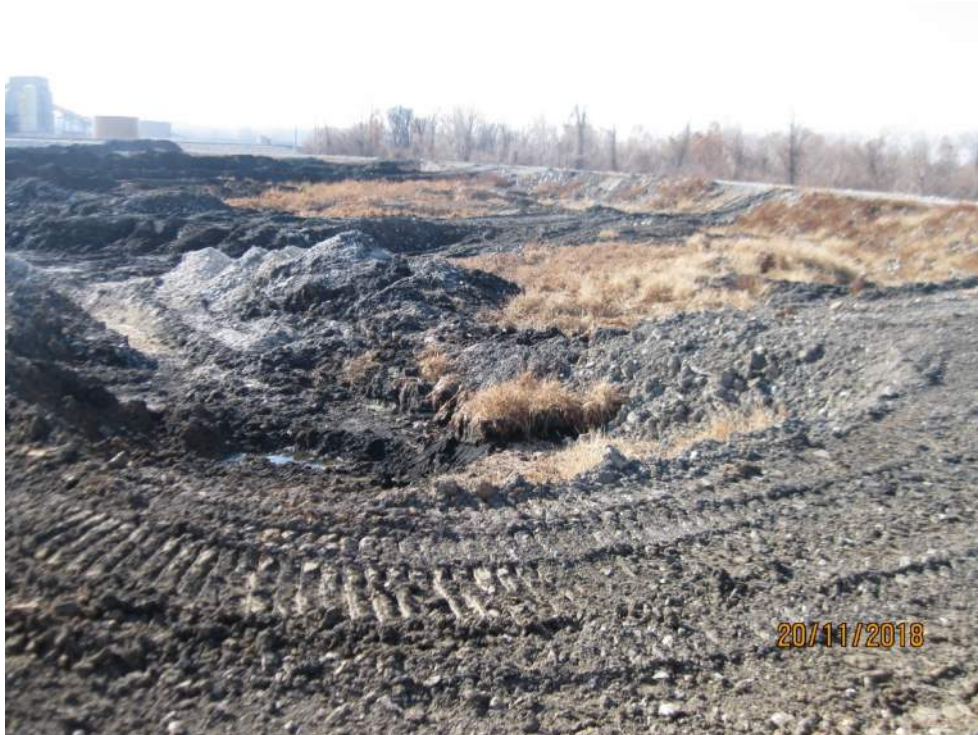
The bottom ash pond was originally designed with a discharge structure that consisted of a 30-inch diameter RCP. The original purpose of the pipe was to permit emergency inflow into the pond in case of exterior flooding to help stabilize the embankments and to allow emergency discharge of impounded water. The pipe had previously been closed by mechanical means and was later sealed with concrete. The bottom ash pond does not impound water for bottom ash. (See Figure 3).

Figure 3 - Dry Condition of Bottom Ash Impoundment

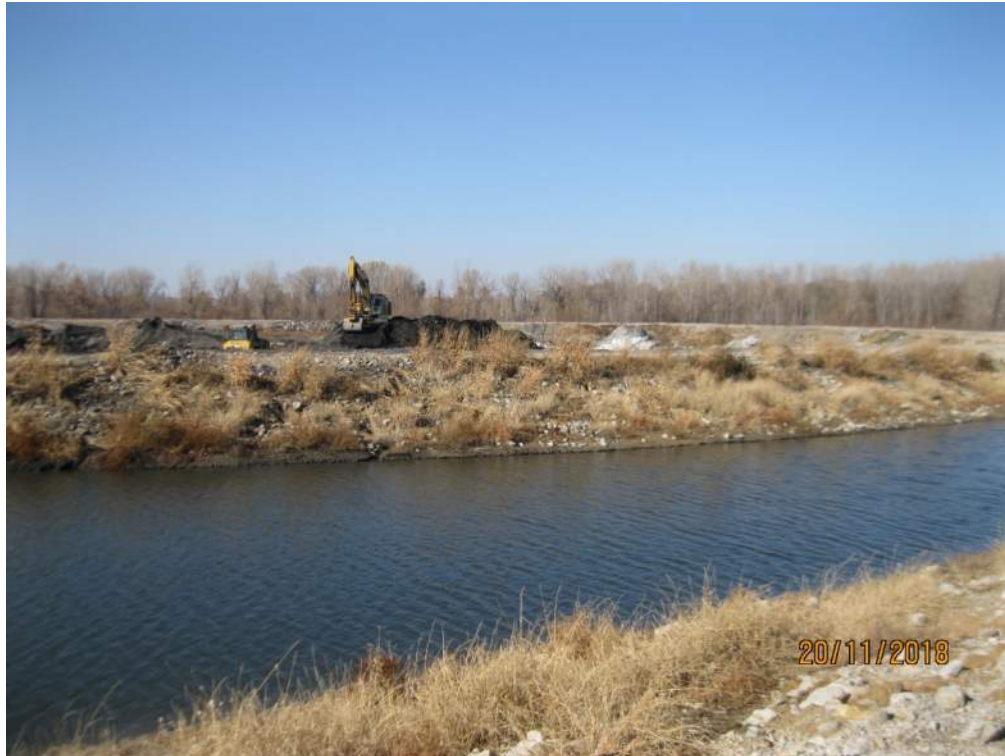
Based on the original construction drawings, the impoundment's exterior and internal dikes have a nominal crest elevation of 763 feet. The side slopes of the dikes, both interior and external are designed with 3 horizontal to 1 vertical slopes. The exterior slopes are covered with riprap on the northern portion only and grass vegetation cover on all other external slopes. The interior slopes were originally designed without riprap cover; however, due to erosion issues, riprap was later placed on all interior slope surfaces. The interior rip rap has been removed as part of the bottom ash hauling for beneficial use. Rip rap was removed from the interior sections of the bottom ash impoundment and the clear water pond. (See Figure 4). Rip rap remains on the exterior of the bottom ash impoundment dike. (See Figure 5).

Figure 4 – Interior Slope of Clear Water Pond without Rip Rap.

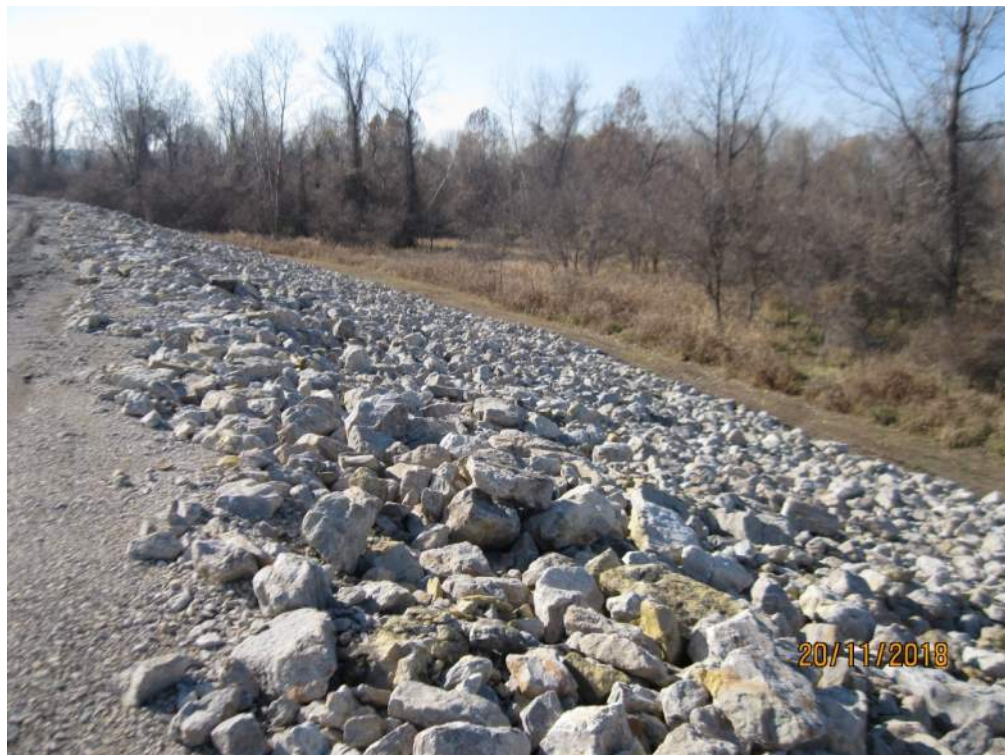
Figure 5 – Rip Rap on Exterior North Dike of Bottom Ash Impoundment

In the northern portion of the impoundment, the exterior dike slope surface is covered with large riprap and appears to be in excellent condition (See Figure 5). There were no indications of slumping or instability observed on this portion of the impoundment. No vegetation was noted within the riprap. The maintenance program includes periodic spraying of vegetation. The base of the slope is dry.

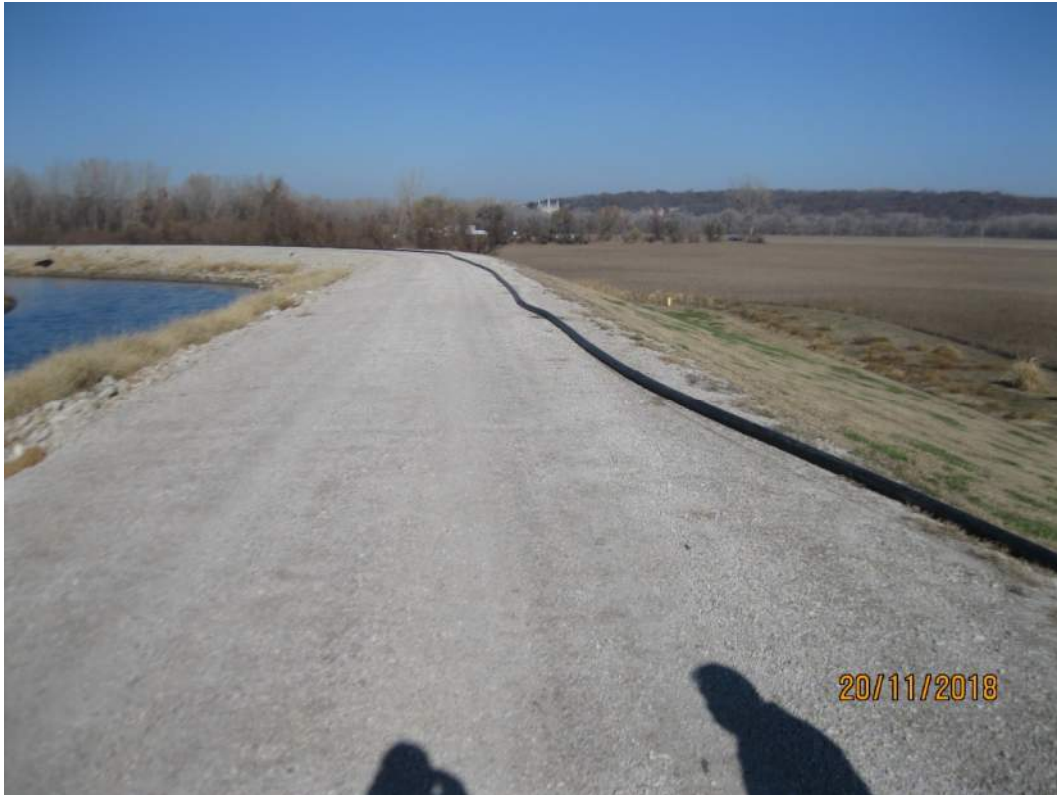
The interior and exterior dike crest surfaces are covered with gravel road base material. The crest of the dikes was in good condition (See Figure 6). No signs of cracking, settlement, movement, erosion or deterioration were observed during the assessment.

Figure 6 - Clear Water Pond Dike Crest Condition

In the remaining portions of the impoundment, the exterior slopes are generally covered with grass and low vegetation cover. There were no indications of slumping, instability, or erosion observed on these portions of the dike. The farmer of the adjacent land had been informed that tilling should not occur within 10 feet beyond the toe of the exterior slope. This can be seen in the right of the embankment pictured in Figure 6.

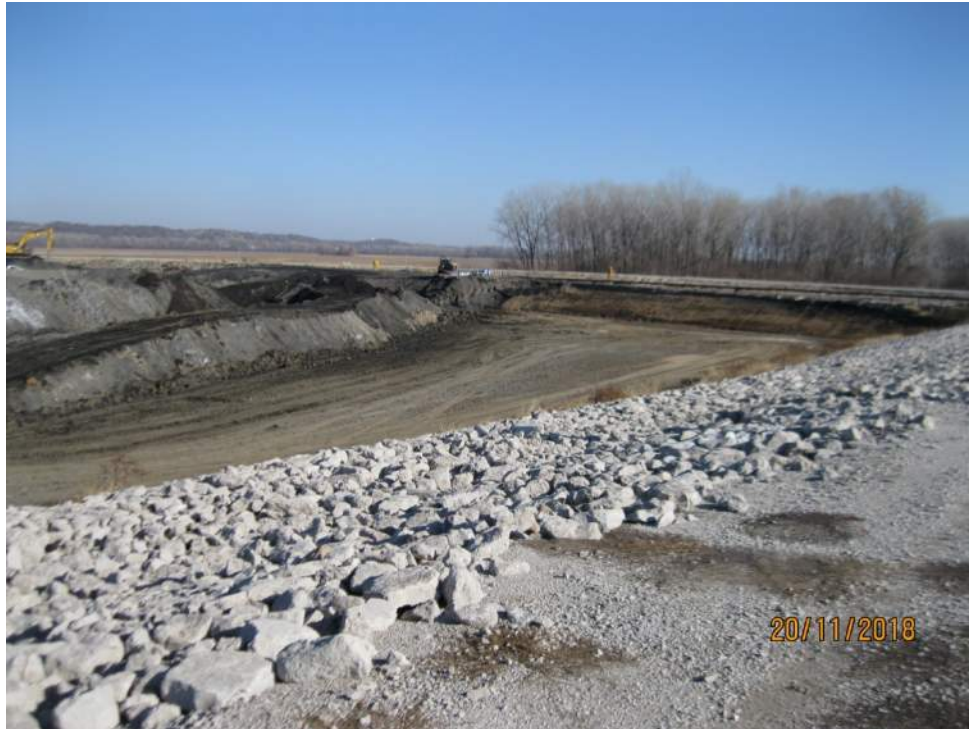
The interior slopes of the bottom ash impoundment are dry and have been shaped as bottom ash has been removed. (See Figure 7). Rip rap has been removed from the interior slopes of the clear water pond but no damage to the slopes was observed. There were no signs of surface instability.

Figure 7 – Shaping of Interior Slopes as Bottom Ash is Removed.
