# ANNUAL INSPECTION REPORT

## NEARMAN CREEK BOTTOM ASH IMPOUNDMENT

Kansas City, Kansas

23 DECEMBER 2019

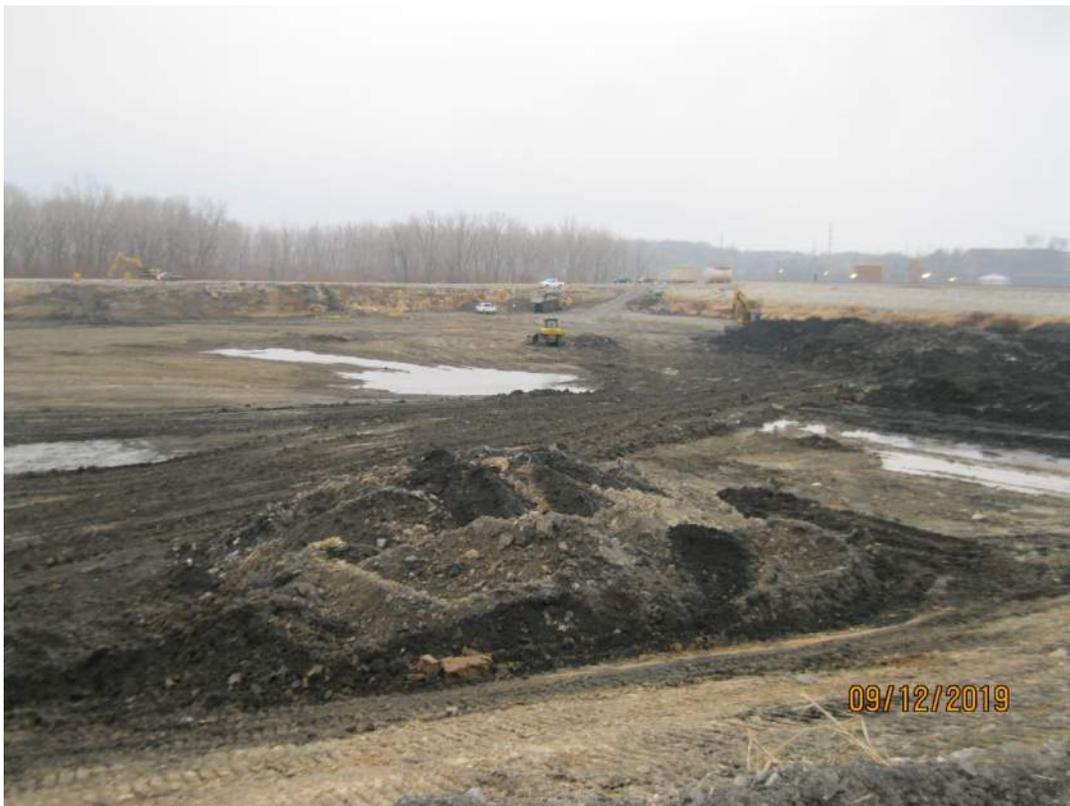
At the time of this inspection, bottom ash was nearing the completion of being completely excavated from the impoundment and hauled offsite for beneficial use. The KCBPU received approval from KDHE on March 16, 2018 for a low-volume wastewater discharge of the surface impoundment via KDHE permit No. I-MO25-B001. The dry condition of the impoundment allowed a single backhoe and multiple dump trucks to excavate and remove the bottom ash. (See Figure 1).

**Figure 1 – Dry Bottom Ash Impoundment – Removal by Backhoe and Dump Trucks**

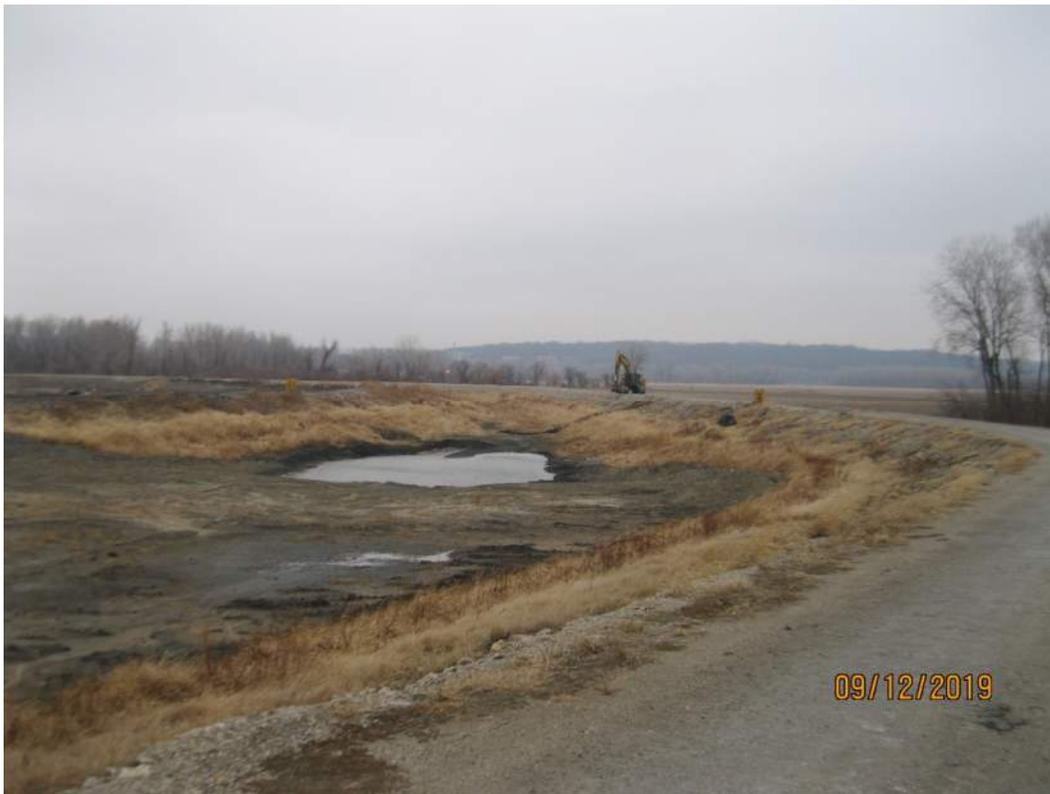
The bottom ash pond was originally designed with a discharge structure that consisted of a 30-inch diameter RCP. The original purpose of the pipe was to permit emergency inflow into the pond in case of exterior flooding to help stabilize the embankments and to allow emergency discharge of impounded water. The pipe had previously been closed by mechanical means and was later sealed with concrete. Currently, the bottom ash pond and settling pond do not impound water for bottom ash. Only intermittent precipitation is collected within the impoundment. (See Figure 2).

**Figure 2 - Intermittent Precipitation Collects in the Settling Pond**

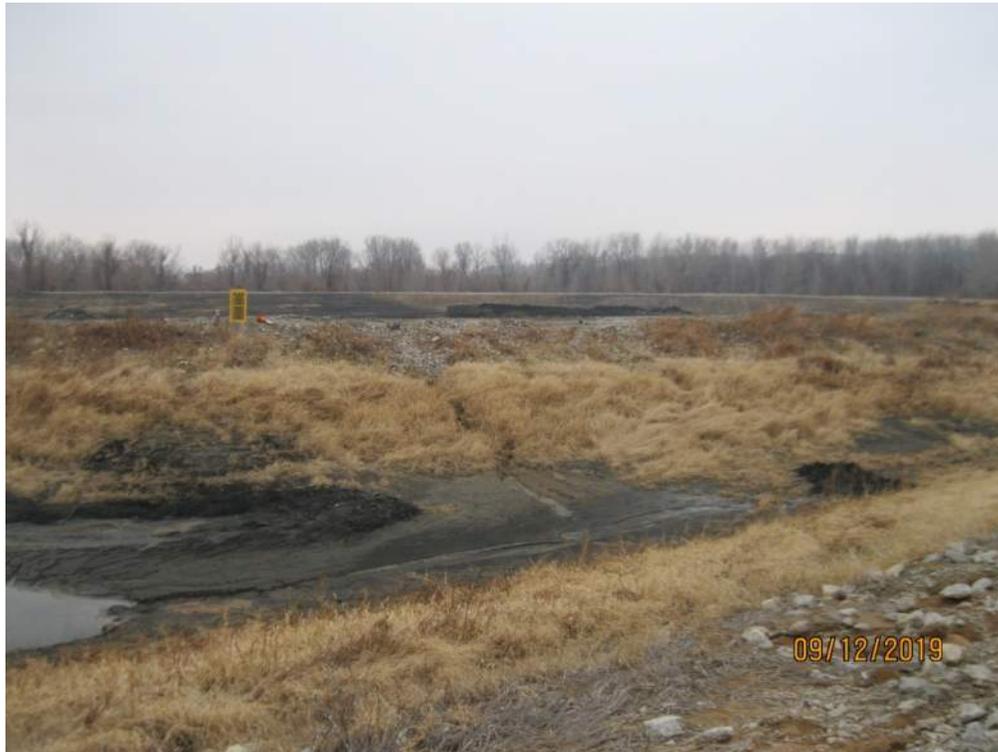
impoundment and the clear water pond. (See Figure 3). Grass has grown over the inside of the ponds. Rip rap remains on the exterior of the bottom ash impoundment dike. (See Figure 4).

**Figure 3 - Interior Slope of Clear Water Pond without Rip Rap.**

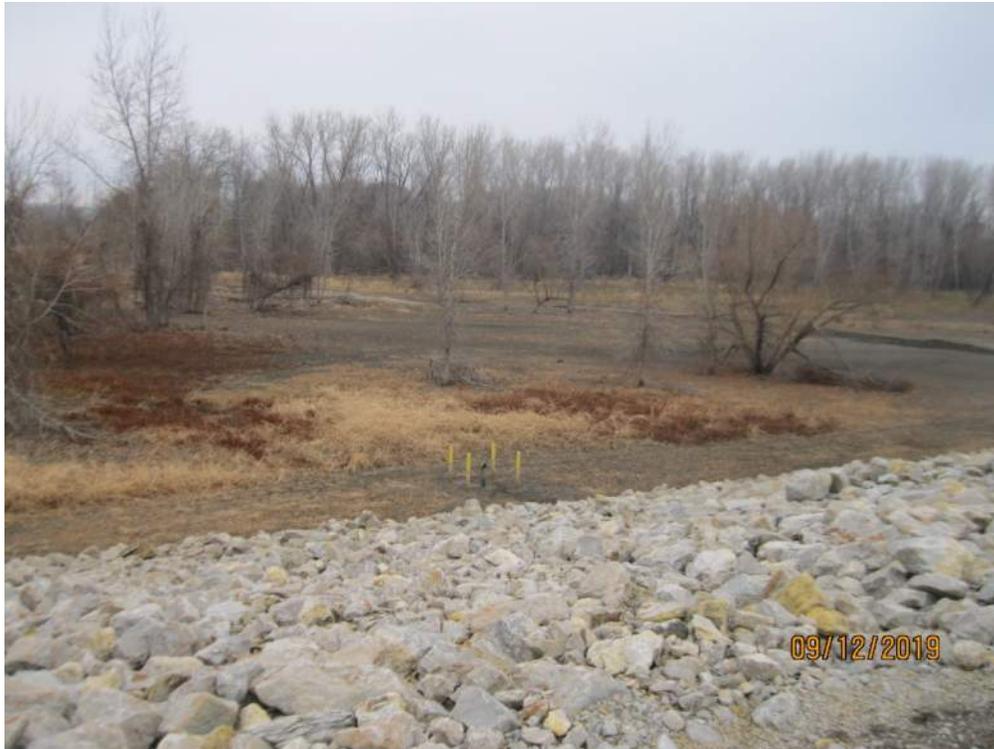
**Figure 4 – Rip Rap on Exterior North Dike of Bottom Ash Impoundment**
